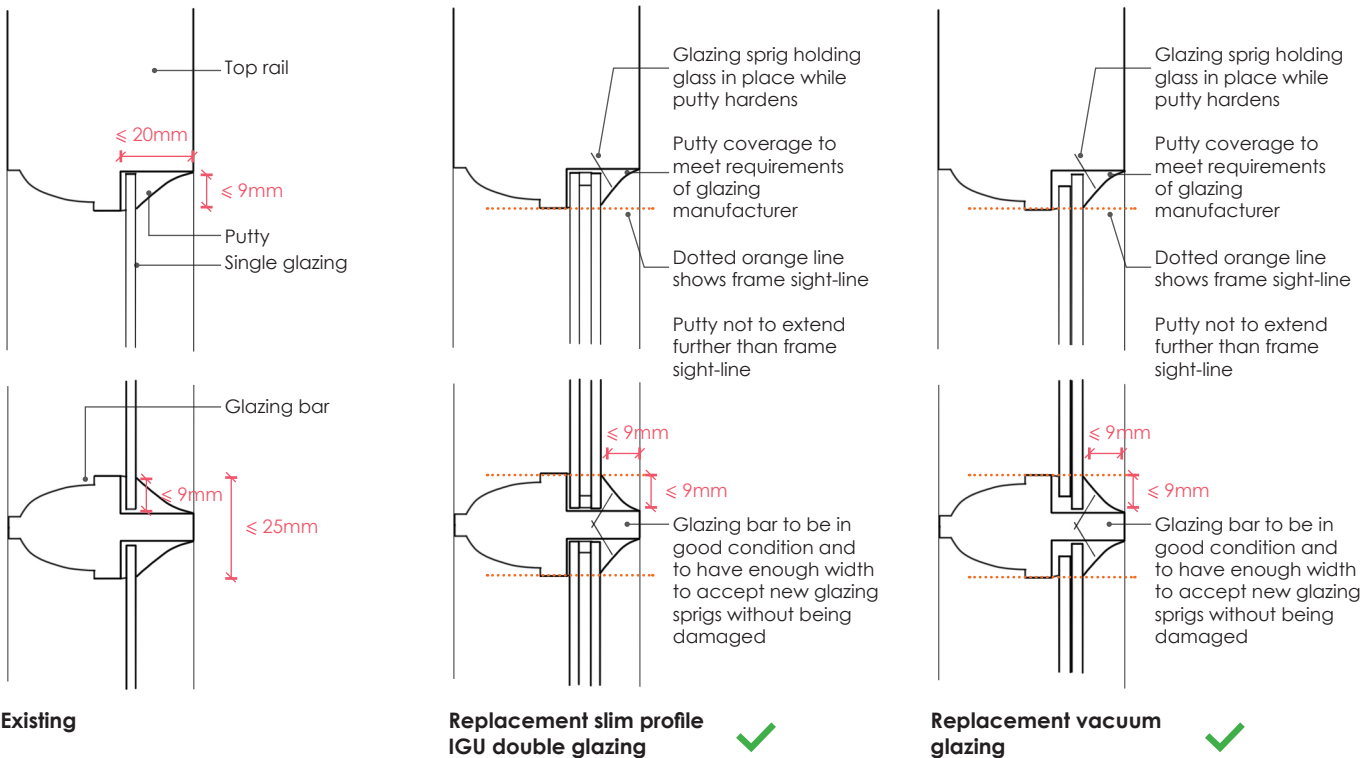
Example showing **acceptable** replacement glazing (Late C19 window and glazing bar)

N.B. all dimensions show 'rule of thumb' minimums.  
actual dimensions should meet requirement of glazing manufacturer for the glass chosen.

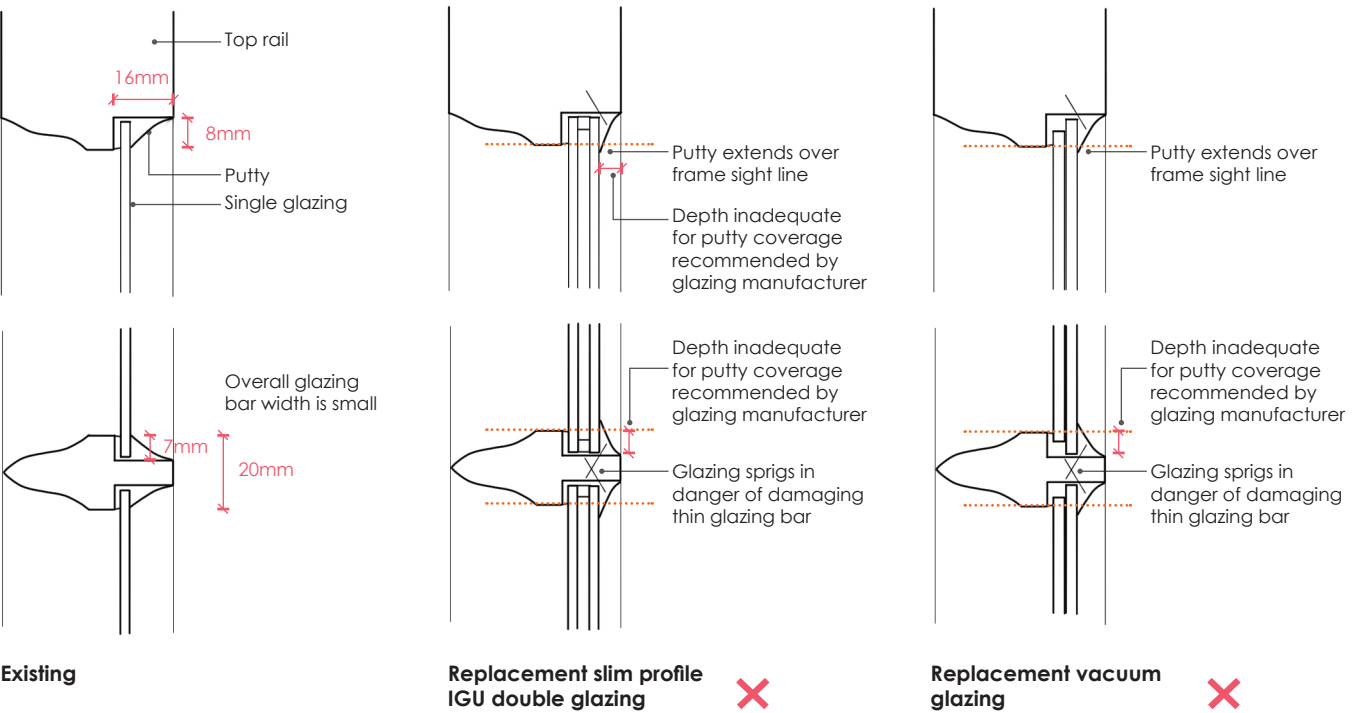
Example showing **unacceptable** replacement glazing (Early C19 lamb's tongue glazing bar)
